MARINE SAFETY ALERT

Safety Alert 06-17

Fuel Spray Fire - Déjà Vu **Prepare and Prevent it from Happening to You!**

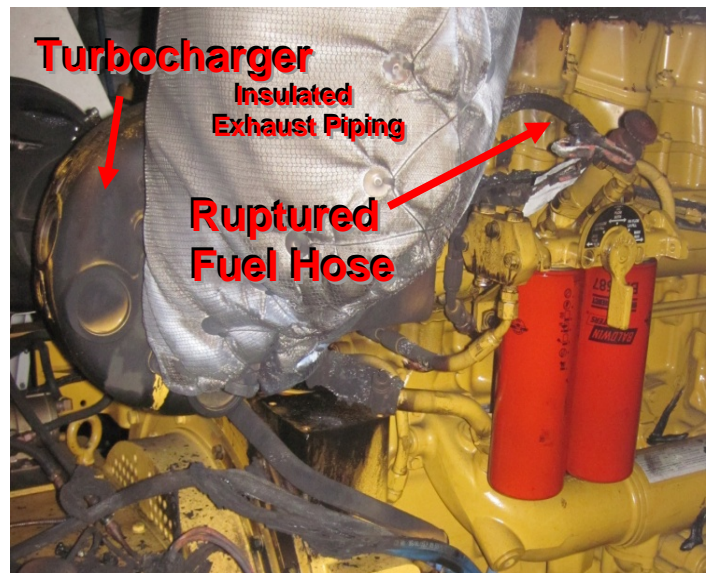
During the post-casualty inspection of the engine room, the source of the fuel leak was identified to be a rupture on a flexible fuel hose connected to the fuel filter assembly. Additionally, it was noted that the fuel filter assembly and its components were installed in relatively close proximity to the turbocharger on the inboard side of the engine. Although components of the turbochargers may be insulated, temperatures on some surfaces typically exceed the fuel's ignition point. In this instance, the heat radiating from the turbo charger components was very high and likely led to the degradation of the flexible rubberized hoses nearby. However, the installation was confirmed to be in accordance with an accepted location on the manufacturer's marine engine manual.

Following the casualty, the owner/operator of the vessel enacted fleet-wide changes and relocated the fuel filter assemblies away from the turbochargers on the outboard side of the engines in the vicinity of the fuel pumps.
