## Carbon Monoxide With Box on Stern

John Collins SBOS ADSO-PE

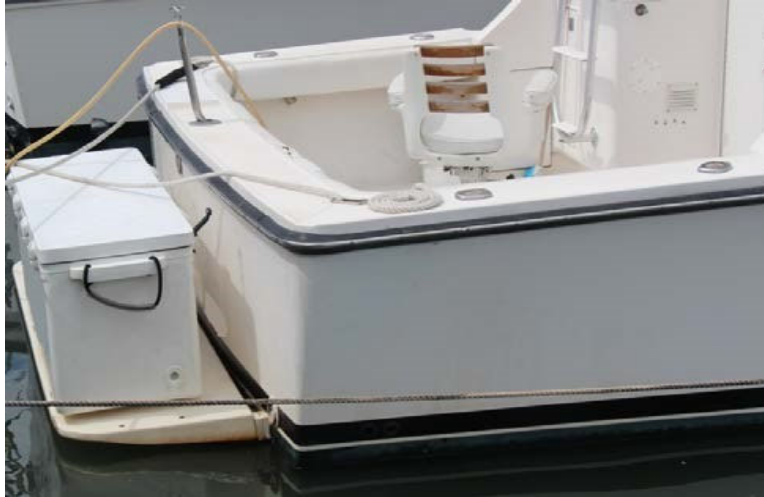
You can see in the photograph above, the sport fishing vessel had a platform mounted near the water level on the transom which supported a large fish container. There was a small space between the platform and the vertical surface of the transom. When the vessel was underway carbon monoxide from the exhaust would get trapped under the platform because its outer edges were submerged in water. As a result, the exhaust vented vertically up through the gap instead of venting away from the vessel's stern like a traditional exhaust would. Due to the draft and eddies created by the vessel when underway the exhaust circulated up over the stern and spread throughout the fishing area, flying bridge, and cabin. Swim decks and other obstacles mounted to the stern can alter exhaust flow, putting passengers and crew at significant risk. This is sometimes called the station wagon effect. Additionally, since the symptoms of sea sickness are similar to other types of illnesses they could be misdiagnosed as something far more innocuous than carbon monoxide poisoning.

The Coast Guard strongly recommends that if you have a similarly outfitted vessel:

- Determine if this type of risk is present on their vessels;
- Always monitor the general health of passengers and crew;
- Consider the use of Carbon Monoxide alarms in cabin areas; and
- Never assume that "it's just sea sickness," when the circumstance could be far more dangerous.
