MARINE SAFETY ALERT

Safety Alert 13-16

WE'RE NOT INFLATING THE IMPORTANCE OF THIS MESSAGE CHECK FOR PROBLEMS BEFORE YOUR LIFE DEPENDS ON IT!

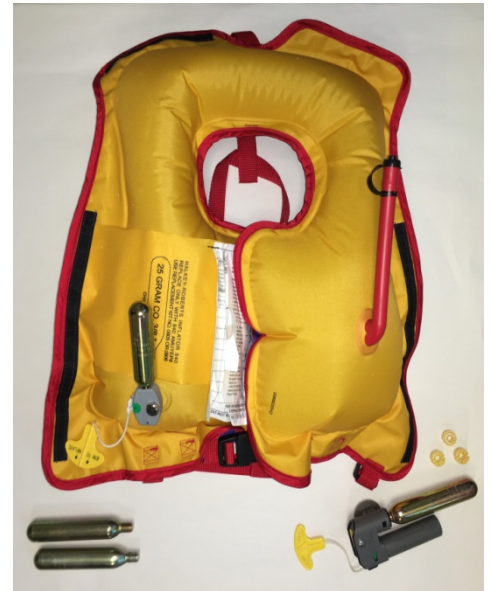
- 1) Each voyage, prior to getting underway:
 - a. If there is a service indicator check it to ensure it is GREEN. If the service indicator is RED the mechanism has been fired or is incorrectly fitted.

- b. Check for visible signs of wear or damage by ensuring that there are no rips, tears or holes; that the seams are securely sewn; and that the fabric, straps and hardware are still strong.

- c. For auto-inflating life jackets, ensure all auto components are armed and not expired. Following the manufacturer's instructions, reveal the inflation system and oral inflation tube. Check that the CO₂ cylinder is firmly secured. Examine it for rust or corrosion. If you remove the CO₂ cylinder for inspection, be sure to carefully replace it without over-tightening.

- d. Repack the lifejacket as per manufacturer's instructions. Ensure the pull-tab lanyard is accessible and unlikely to be caught when being worn.
- 2) Periodic checks as recommended by the manufacturer or when in doubt:

- a. Inflate the bladder using the oral tube and leave it overnight in a room with a constant temperature. If the bladder loses pressure, take the lifejacket to an authorized service center for further tests. Do not attempt to repair a life jacket yourself. If there is no obvious loss of pressure, deflate the life jacket by turning the cap of the inflation tube upside down and pressing it into the inflation tube. Gently squeeze the inflatable life jacket until all air has been expelled. To avoid damage do not wring or twist the life jacket.

- b. Repack the lifejacket as per manufacturer's instructions. Ensure the pull-tab lanyard is accessible and unlikely to be inadvertently snagged when being worn.
